FLOOD PLAIN MANAGEMENT

**A Study Of South Fork
Shenandoah Tributaries**

MILL CREEK – CONGERS CREEK

TECHNICAL REPORT
MILL CREEK - CONGERS CREEK

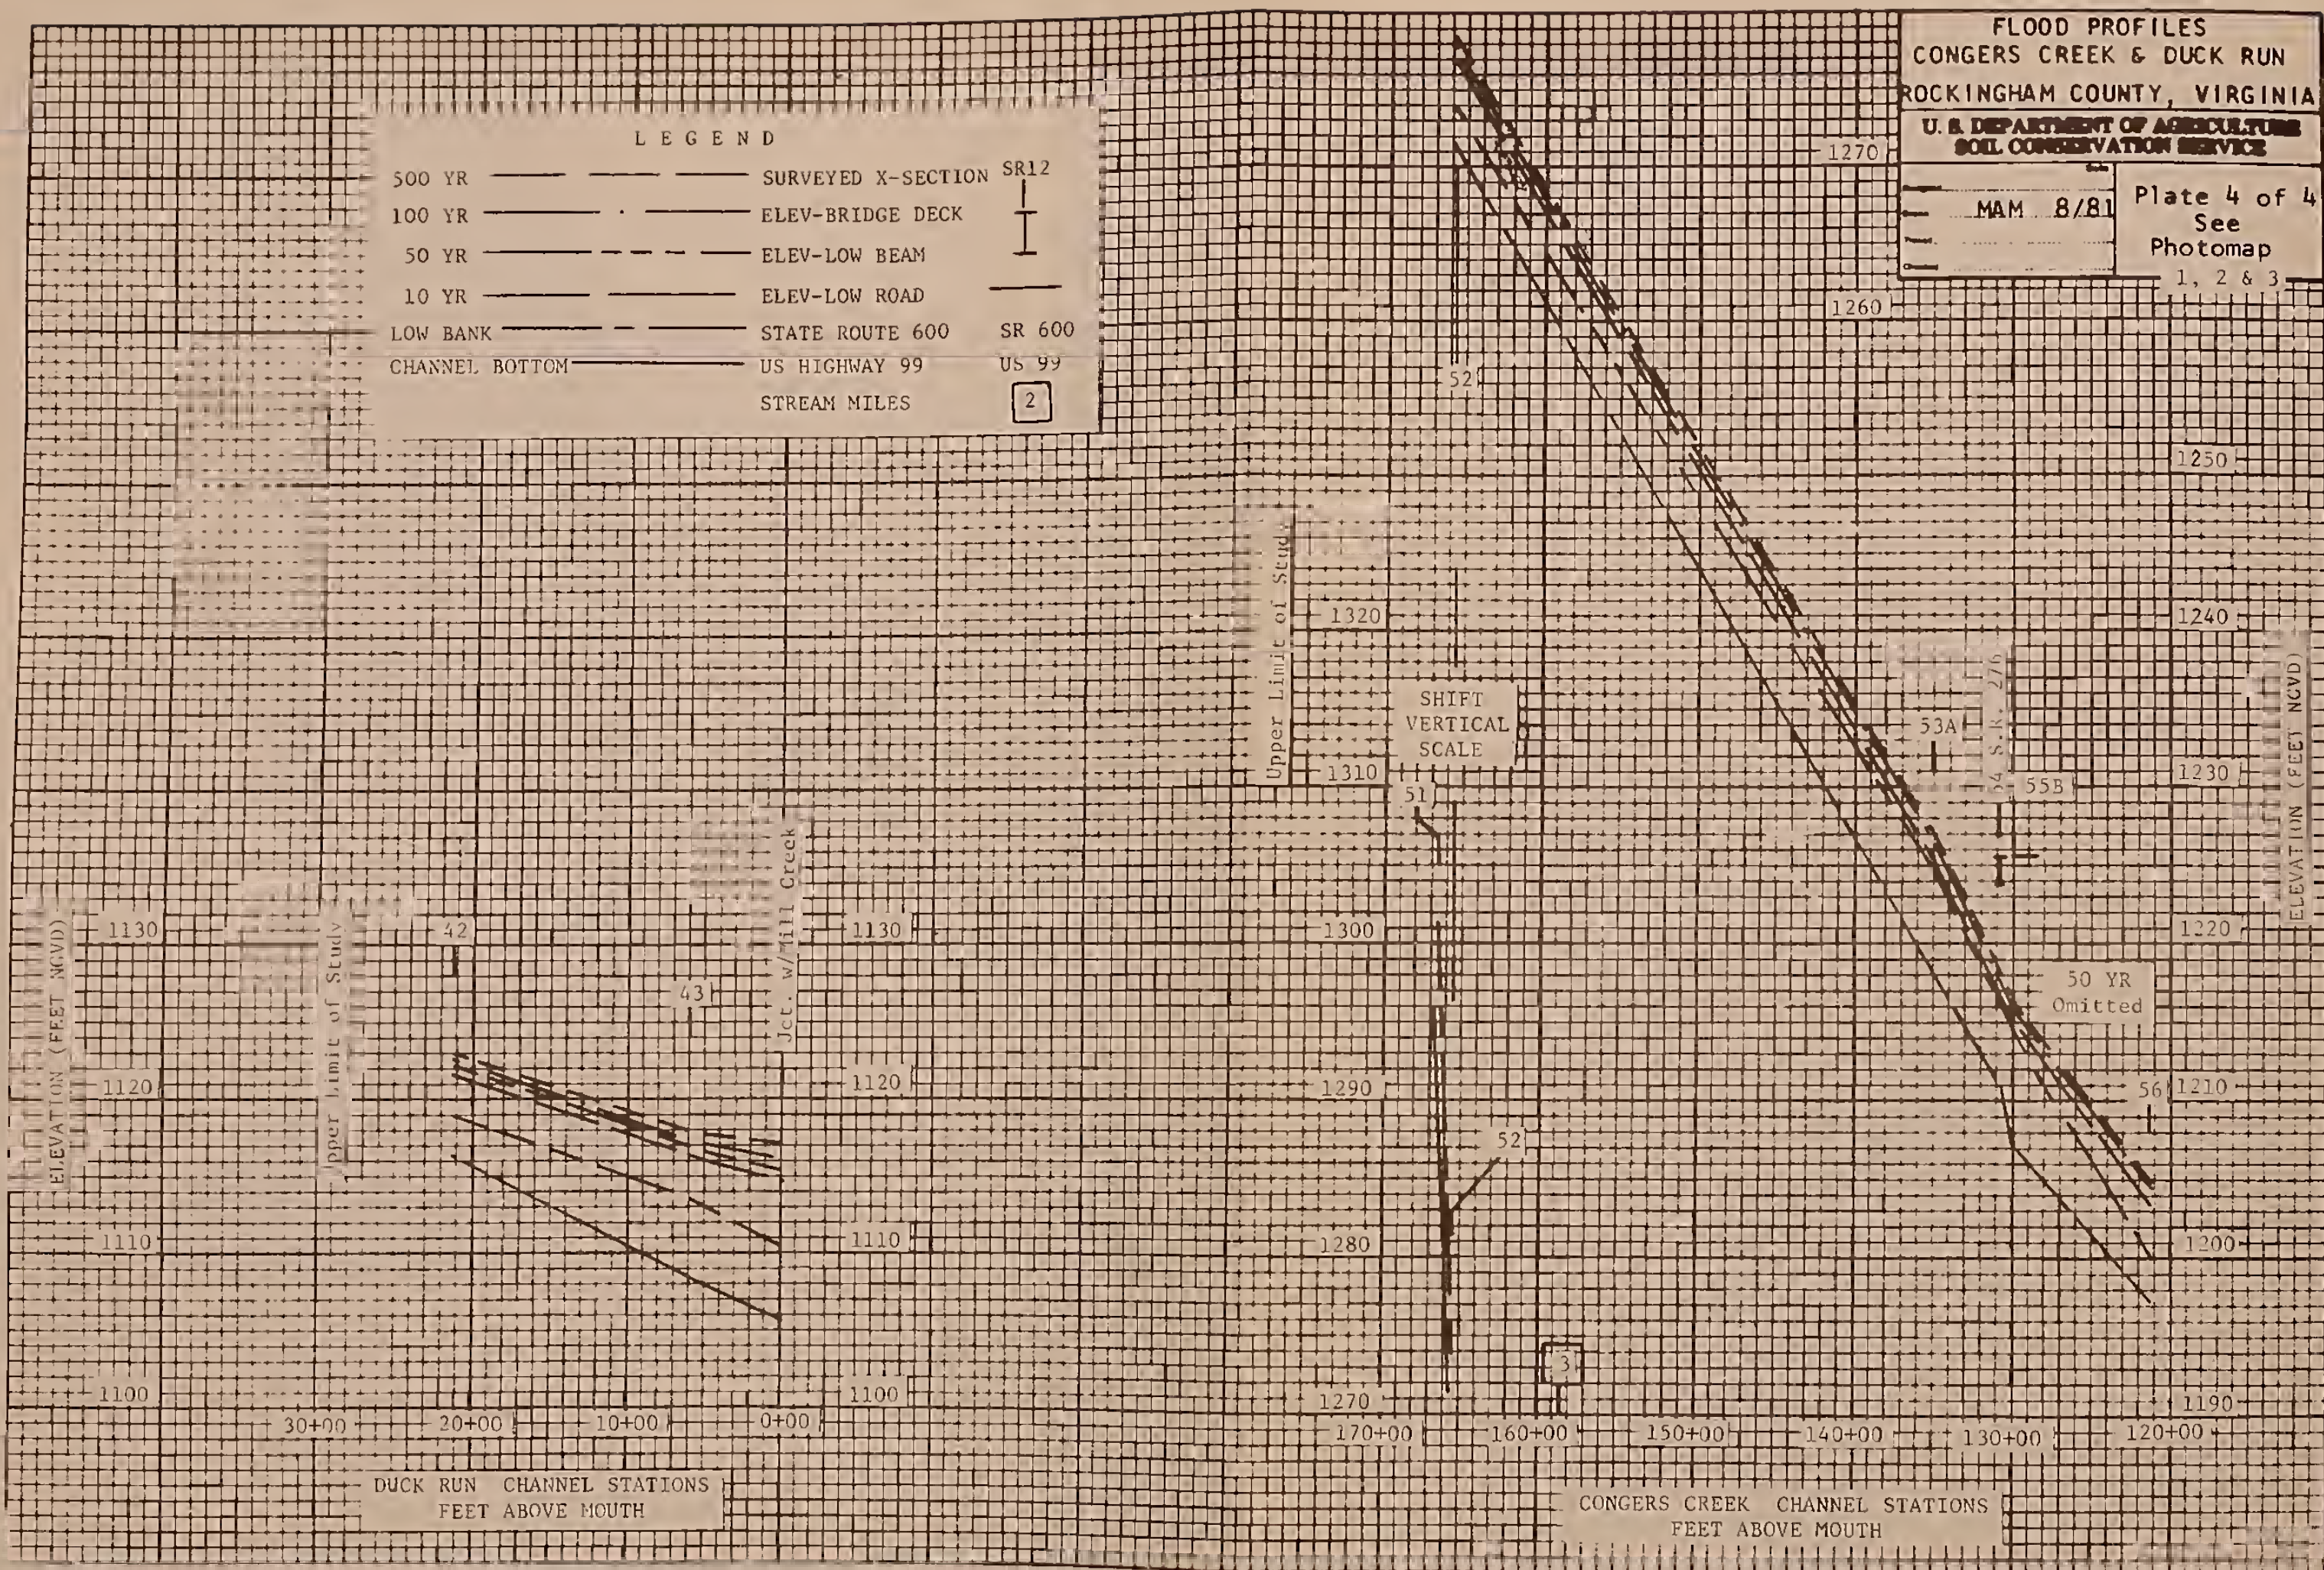
TYPICAL CROSS SECTIONS
MILL CREEK
ROCKINGHAM COUNTY, VIRGINIA

CROSS SECTION - 18

CROSS SECTION - 23A

Flood profile plates provide elevations of the 10, 50, 100 and 500-year floods at any location along the length of the streams. The elevations and discharges of the 10, 25, 50, 100 and 500-year flood at each surveyed cross section are given in Table MC-1. Sample cross sections illustrated how the flood area boundaries were located. Table MC-2 provides the description and elevation of benchmarks which are located on the photomaps.
